Manhole Inspection Summary

Manhole # S04AA2022MH

Location Address: **3700 WILLIAMSON AVE**

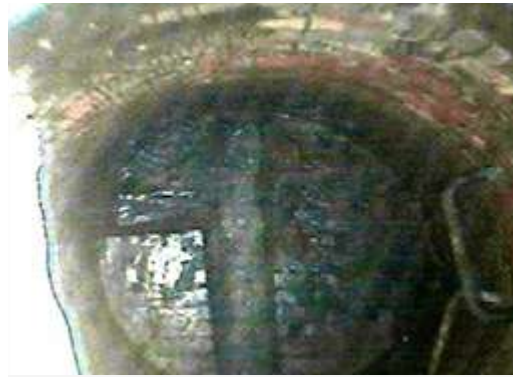
Top View

Corroded steps. Bench debris.

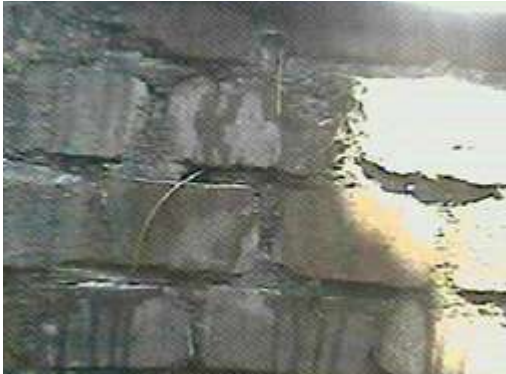
Defect

Condition: ☐ Sound ☐ Cracked ☐ Root Intrusion ☐ Loose Brick ☒ **Deteriorated**

Infiltration: ☐ None ☒ **Joint** ☐ Cracks ☒ **Mortar** ☐ Roots ☐ Wall

Infiltration: ☐ None ☐ Joint ☐ Cracks ☒ **Mortar** ☐ Roots ☒ **Wall**

Adjustment and Corbel deterioration and infiltration.

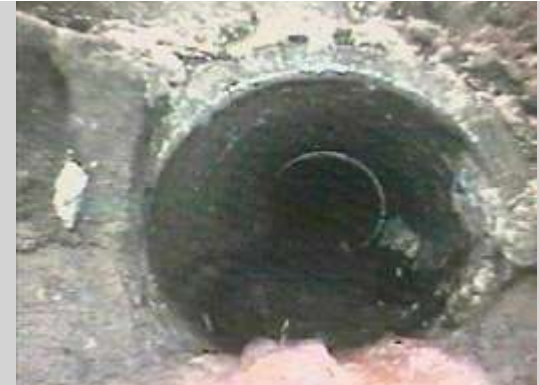
8 in. Circular Gravity Sewer Pipe Out @ 12 O'Clock

Rod and Bar (Angled)

Infiltration: **None** Pipe Seal Cond: **Unknown**

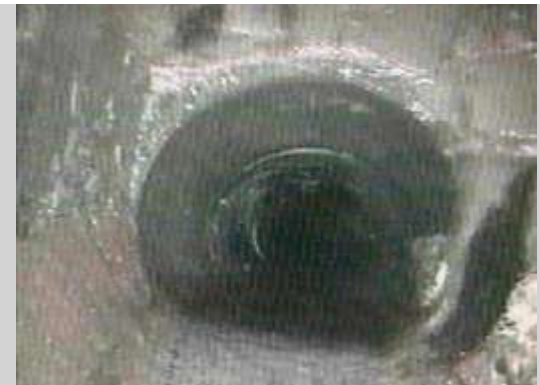
8 in. Circular Gravity Sewer Pipe In @ 6 O'Clock

Rod and Bar (Angled)

Infiltration: **None** Pipe Seal Cond: **Unknown**

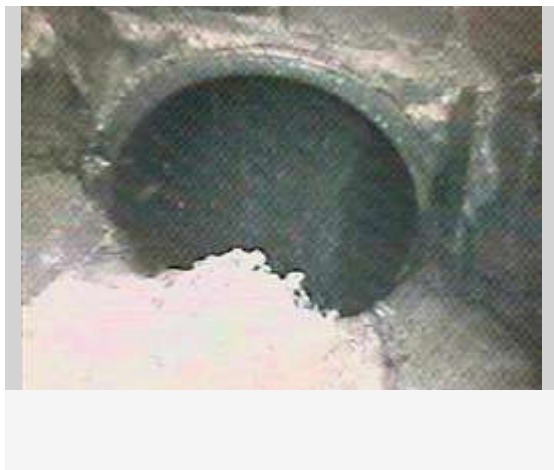
8 in. Circular Gravity Sewer

Rod and Bar (Angled)

Infiltration: **None**
